92-97 4R70W repin for using 98-08 trans:

In 98 the hard connector replaced the internal wire harness...and a repin or solenoid swap is required. The following info is regarding a repin of the 92-97 chassis harness.

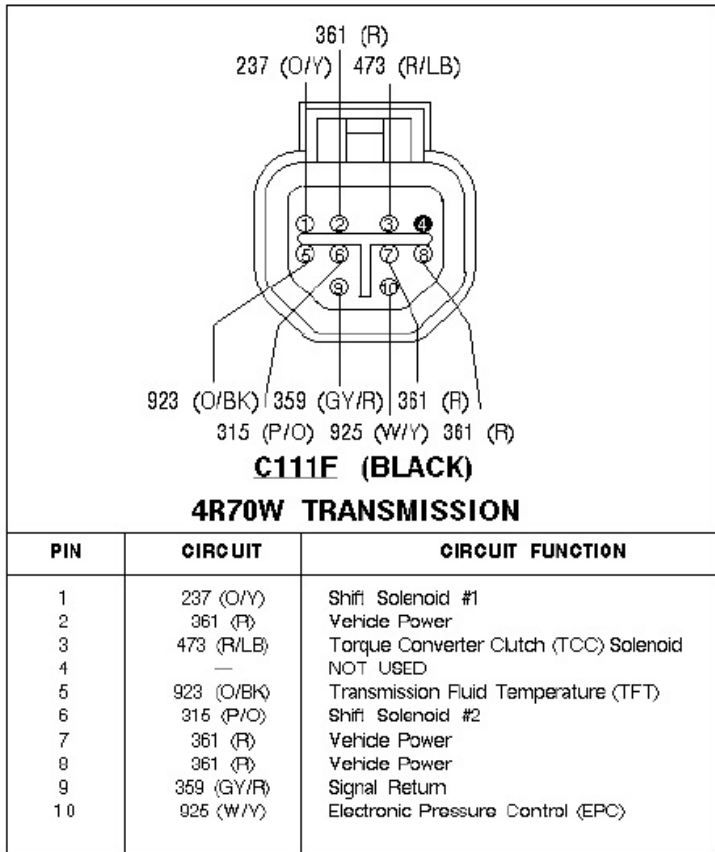
1992-1997

Here is the factory diagram looking INTO the chassis connector.

In the 92-97 chassis harness connector, using small screw driver, disassemble the connector all the way down to the internal rubber insulator. Remove and place these wires...color can vary, so I describe in terms of position. You will need to drill HOLE 4 in the harness connector.

-
- 10 to 6
 - 9 to 2
 - 8 to 10 or leave out
 - 7 to 9 or leave out
 - 6 to 8
 - 5 no change
 - 4 blank, DRILL, put 2 here
 - 3 no change
 - 2 to 4 (12v+)
 - 1 to 7
